Improvement of Pedestrian and Bicyclist Safety

- Addressing Environmental Contributing Factors -

Dohyung Kim (Assistant Professor, Department of Urban and
Regional Planning, California State Polytechnic University, Pomona)

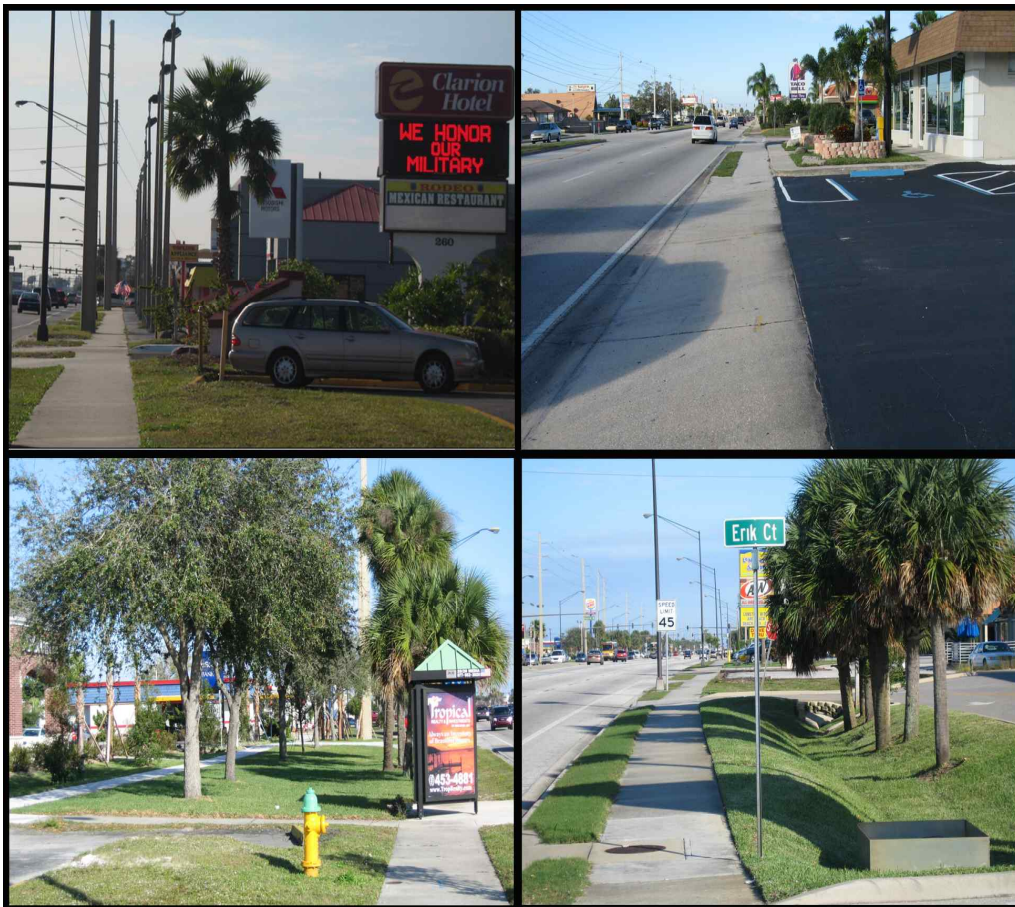
Figure 2. Typical conditions of sidewalks

Two photos on the top illustrate the conditions of Courtney Parkway and the bottom two photos are from Merritt Island Causeway.

outstanding example of roles of sidewalk landscape on pedestrian/bicycle safety. Large portion of Merritt Island Causeway is decorated with planters and aligned street trees along sidewalks, holds extra green spaces between sidewalks and parking lots, and is placed with proper street furniture including benches and shaded bus stops. In contrast, Courtney Parkway absolutely lacks all of the amenities: it is hard to distinguish sidewalks from parking lots along most portion of Courtney Parkway, narrow sidewalks are located right next to parking lots, and unorganized street light poles block pedestrian and bicycle flow. Figure 2 illustrates typical appearance of sidewalks on both Courtney Parkway and Merritt Island Causeway. Those pictures are probably eligible evidences demonstrating the difference of landscape conditions of those two corridors.

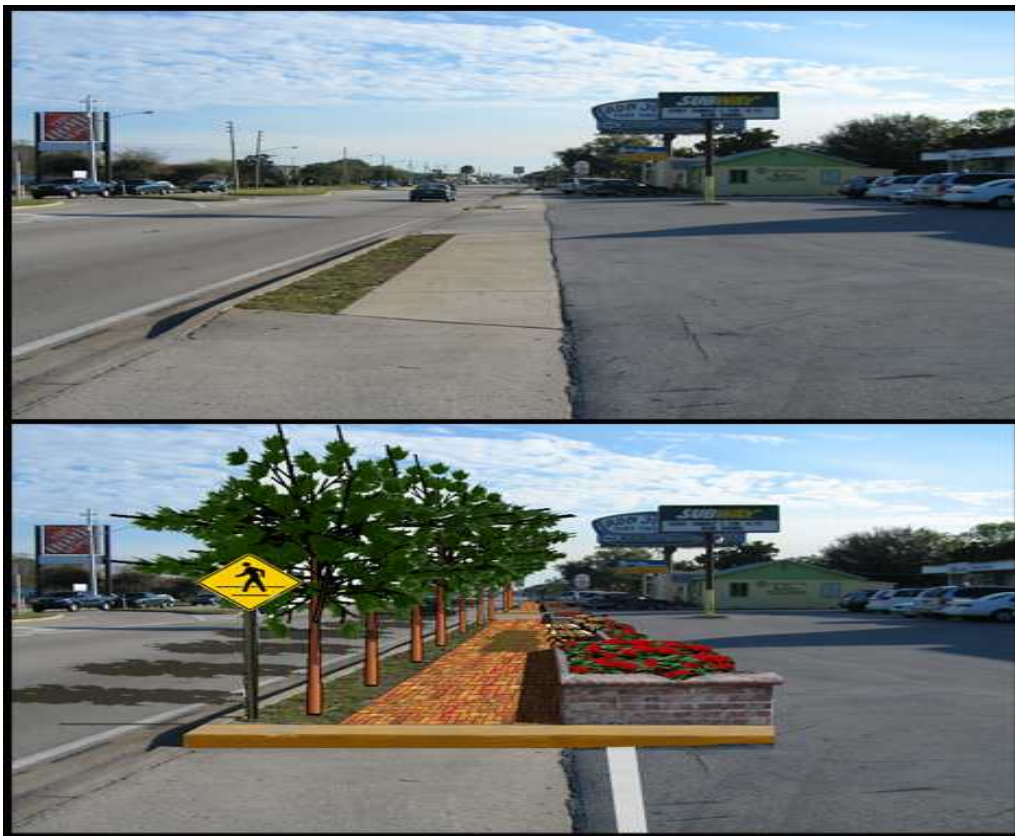
Figure 5. Example of improved sidewalk landscapes

The first landscape design recommended was to build curbs on sidewalks, which meet parking lot entrance ways. Currently there are no levels or borders between most of parking lot entrance ways and sidewalks. Automobiles passing through the entrance ways overrun to sidewalks without any barriers, and pedestrians and bicyclists walk and bike without recognizing that they are in dangerous zones.

The curbs differentiating levels between the sidewalks and the entrance ways will prevent automobiles from invading to the sidewalks as well as warning pedestrians and bicyclists as they walk or bike into the entrance ways. Second, it is necessary to create planters between sidewalks and parking lots in order to

physically separate pedestrians and bicyclists on sidewalks from automobiles in parking lots. Large portion of sidewalks on Courtney Parkway is barely distinguishable from parking lots. Of little less than 1 mile, precisely 0.95 mile, of the sidewalk located right next to parking lots, only 0.53 mile (55.8%) of the sidewalk have physical buffers such as lawn or walls from parking lots. The other 0.42 mile of the sidewalk has no clear separation from parking lots. Creating planters between the sidewalks and the parking lots is a practical resolution since there is not much space between the sidewalks and parking lots. Third, planting street trees along sidewalks offers protective walls to pedestrians and bicyclists. Currently, there is existing lawn along Courtney Parkway, but there are no trees planted. Therefore, planting trees is relatively easy to implement. Figure 5 illustrates a typical street segment's current and improved environments as recommended above.
